Probable Damage

Lessons learned from the 2005 Fukuoka-oki M7 earthquake

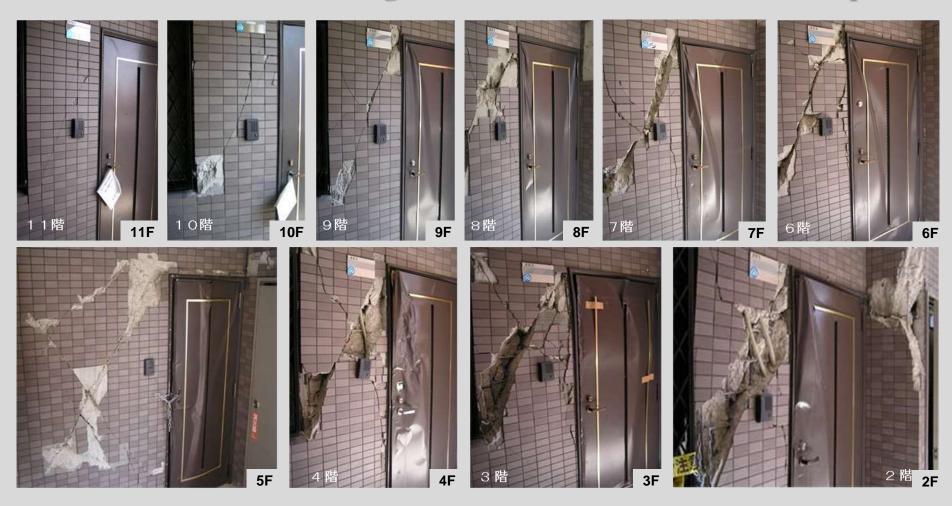
Non-structural damage of a 14-storyed residential building, during the 2005 Fukuoka-oki M7 earthquake

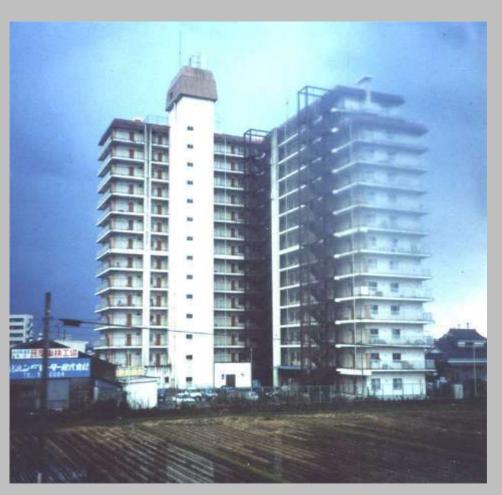
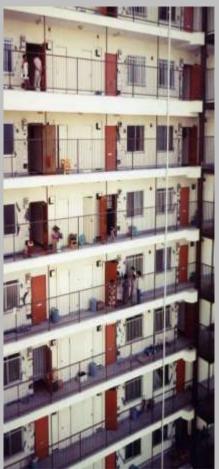
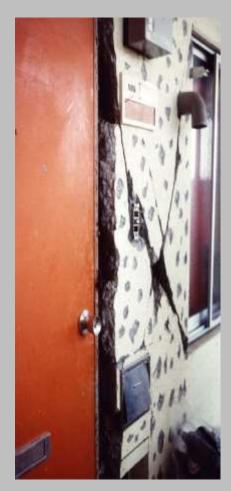
Building dispute may happen between the construction company and the residents. Will the residents in Tokyo metropolis permit similar damage? Maybe no!

Similar damage had been found in Sendai already in the 1978 earthquake. At that time, the construction company paid the expense for repairing the building. Unfortunately this building had suffered more severe damage in The 2011 earthquake, and finally demolished.

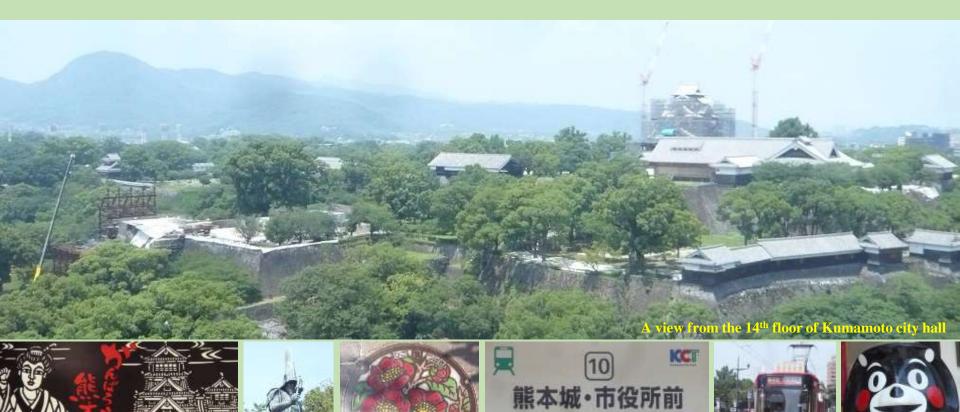
Kumamoto castle after 2 years since the 2016 earthquake
