The Hokkaido M6.7 earthquake happened in the early morning of Sept. 6, 2018.

Very large-scale land failures happened near the epicentral region

Damage of thermal power plants caused serious electric outage (blackout) in whole of Hokkaido

Liquefaction phenomena were found in a southeastern part of Sapporo city

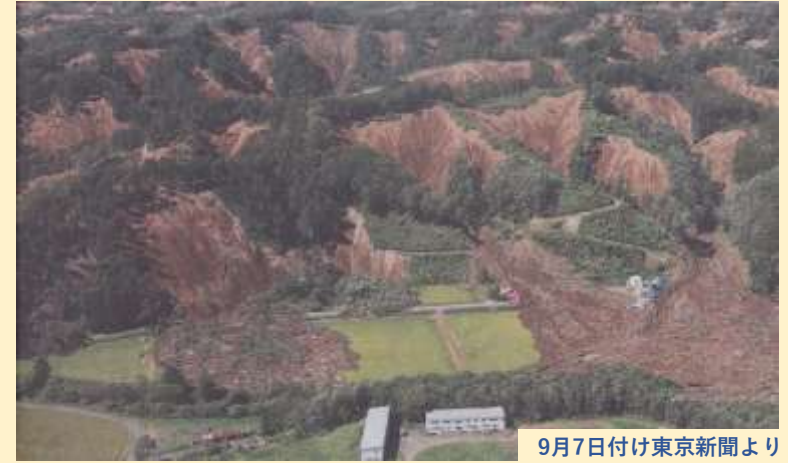
NHKが9月7日に放映した厚真町の大規模斜面崩壊の様子

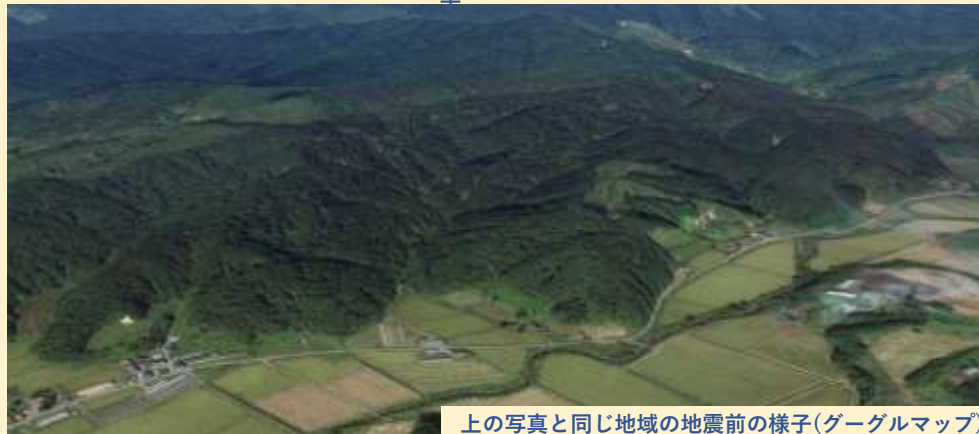
9月7日付け東京新聞より

上の写真と同じ地域の地震前の様子(グーグルマップ)

Before and after comparison was examined with the help of Google map.

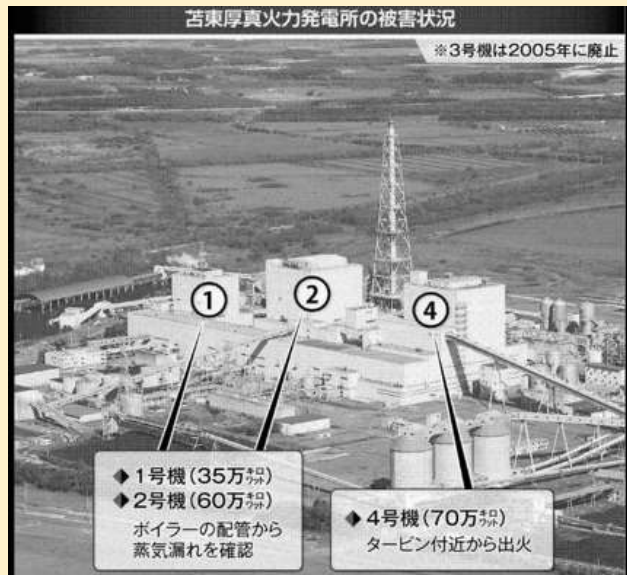
9月8日付け北海道新聞より

Almost 3 million houses suffered the complete electric outage in whole of Hokkaido.
 北海道電力苫東厚真火力発電所の被害に伴う北海道全域295万戸の停電

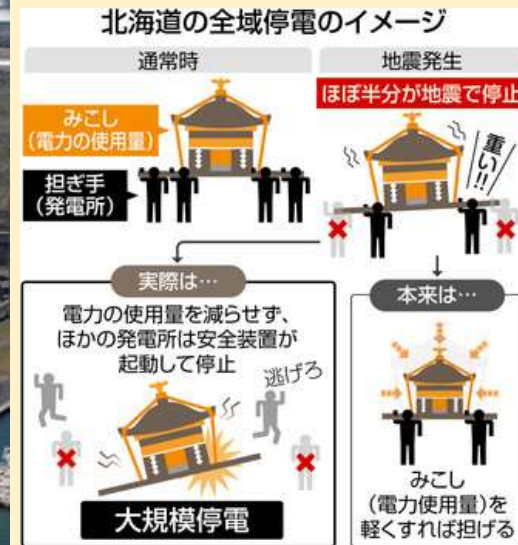
9月13日付け東京新聞より

北海道の全域停電のイメージを説明する『おみこし理論』

震度7を観測した厚真町にある苫東厚真発電所1,2,4号機の3基のうち、2,4号機の2基が発生直後に緊急停止した。2基の供給力は計130万キロワットで、当時の電力需要310万キロワットのうち4割をまかなっていた。電力システムは家庭や工場が使う量(需要)と、発電所が発電する量(供給)のずれが一定以上大きくなると、工場の機械が故障したり停電したりする。通常はずれが起き始めると、供給や需要を自動的に増減してバランスを保つ。需要を「みこし」に、供給を「担ぎ手」に例えると、一部の担ぎ手がいなくなれば、残った担ぎ手がさらに頑張るか、他から応援を得るよ

ような仕組みだ。北海道でも2,4号機の停止で足りなくなった130万キロワット分を補おうと、この仕組みが働いた。国の電力広域的運営推進機関によると、地震発生5分後には、北海道と本州をつなぐ連系線で本州から送り込まれる「応援」の電気が最大容量の60万キロワットになった。ほかの道内にある発電所も供給を増やしたとみられる。また需要側でも北海道電力は一部地域を停電させて、需要を減らすシステムは作動したとしている。しかし、地震発生から18分後の午前3時25分に何らかの原因で全域停電した。(9月13日付け東京新聞の記事より)

Newspaper has reported that the electric need is supported by the electric supply and the balance between them is surely necessary. We can compare this situation to Mikoshi (portable shrine) in a shrine festival of Japan. Mikoshi requires enough number of supporters to keep the balance. Otherwise a trouble will happen!

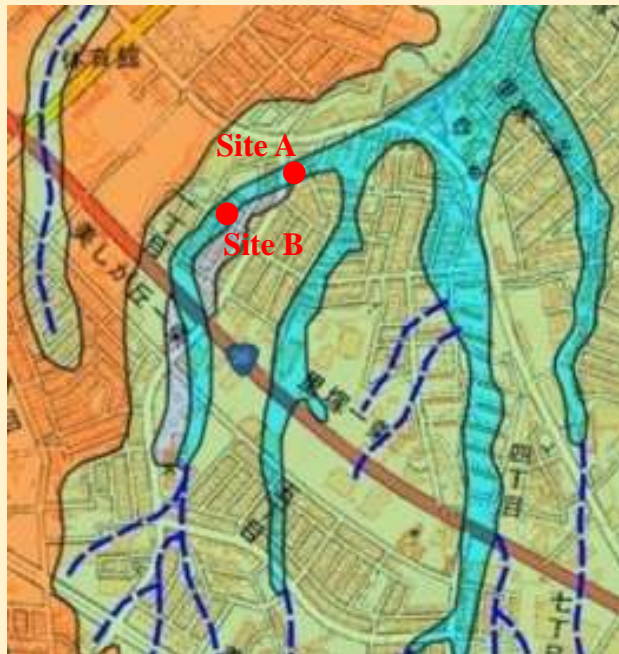
Recent development covered an old river flow, and district citizens as new comers did not know the original soil condition at all. The similar problem could be seen almost everywhere in the world.

Geospatial Information Authority of Japan has immediately prepared this map after the earthquake.

Blue: river or lowland

Green: hilly zone

Brown: plateau or platform

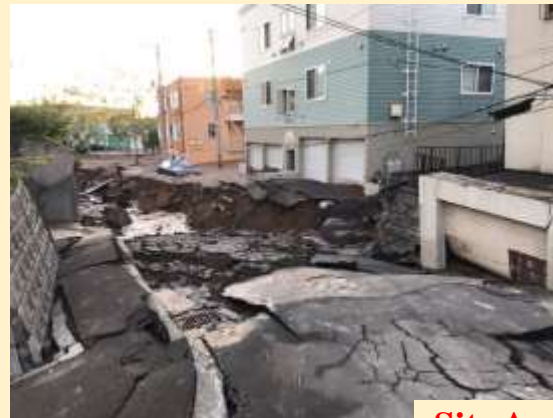
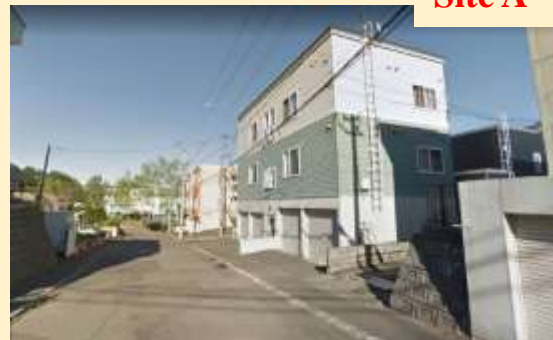
Site A

Now a days we can confirm the condition before the damage by means of Google map.
